NATIONAL ADVISORY COMMITTEE FOR AERONAUTICS

REPORT 1363

ORIGIN AND PREVENTION OF CRASH FIRES IN TURBOJET AIRCRAFT

**Lewis Flight Propulsion Laboratory
Cleveland, Ohio**

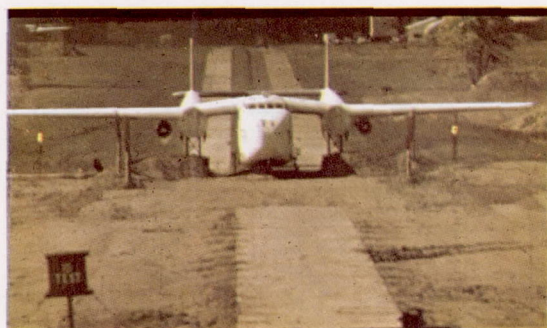
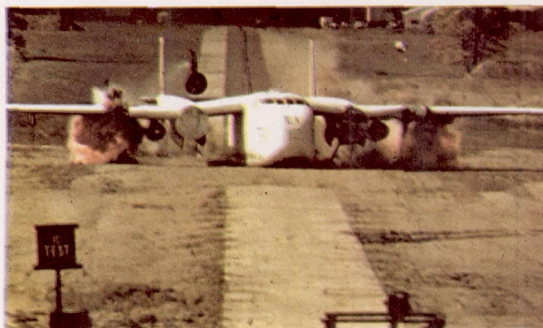
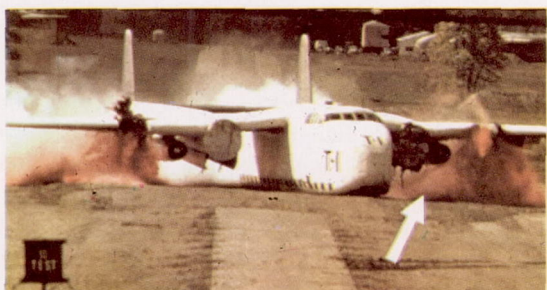
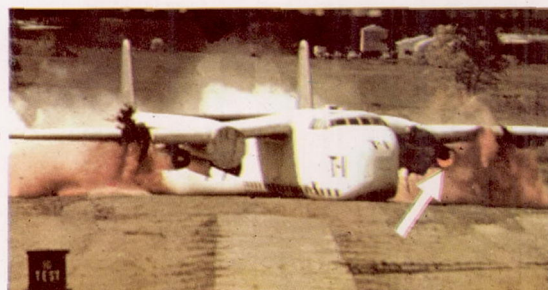
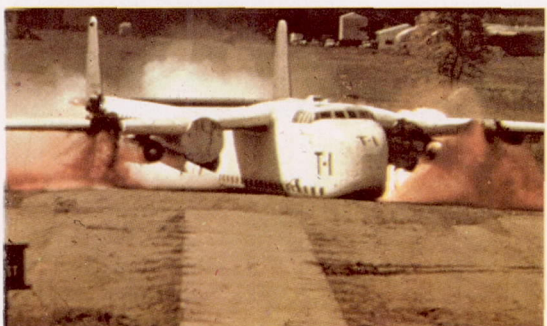
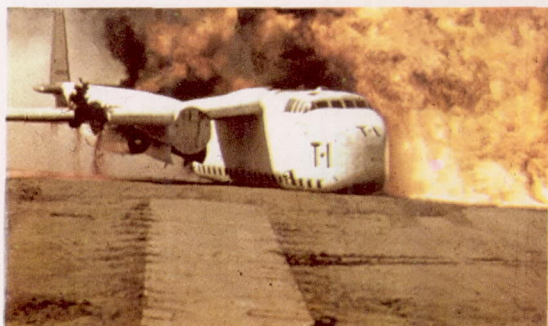
FIGURE 2.—Development of crash fire in simulated jet bomber.

(a) Airplane contacting barrier.

(b) Fuel-mist cloud, 0.8 second after initial impact.

(c) Fuel mist entering left engine, 2.5 seconds after initial impact.

(d) Fire at engine inlet and tailpipe of left engine, 2.6 seconds after initial impact.

(e) Fire spread to fuel mist issuing from left wing, 2.8 seconds after initial impact.

(f) Spread of fire, 4.0 seconds after initial impact.

Flames originating within the engine may also appear at the engine inlet as observed in figure 2(d). The appearance of this inlet flame may be explained in the following way. Burning of ingested fuel in the combustor flame reduces the turbine inlet gas density. A higher pressure in the combustor is required to pass the gas through the turbine. When an abrupt change in over-all combustor fuel-air ratio is provided by the ingested fuel, the pressure in the combustor required to pass the combustor gas through the turbine may exceed the capability of the compressor at the existing rotor speed. The compressor flow may stall before the turbine can accelerate the rotor to a speed that will provide the necessary pressure. At this moment the combustor flame may propagate upstream through the ingested combustible mixture that fills the stalled compressor and exit at the engine inlet.

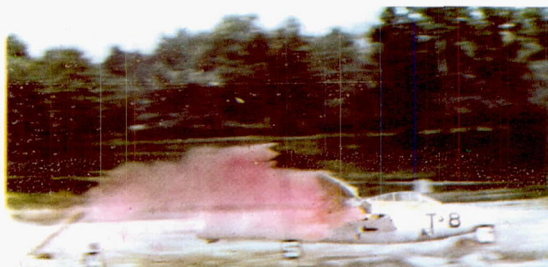
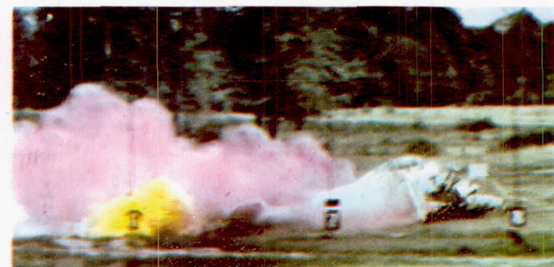
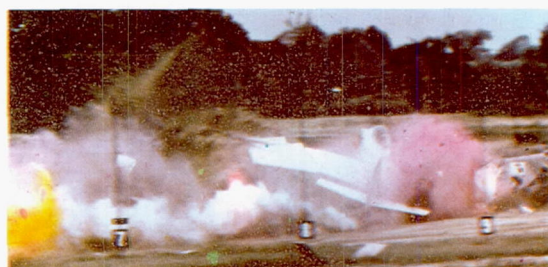
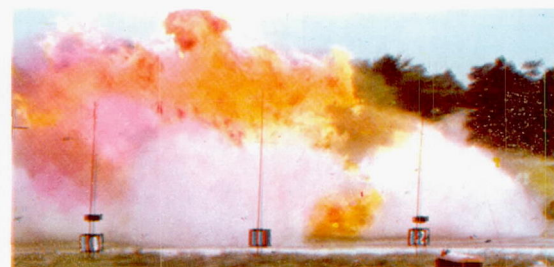
FIGURE 5.—Development of crash fire in jet fighter.

A crash of the F-84 is shown in the sequence in figure 5. Upon passing through the crash barrier the airplane flew over a ditch toward rising ground. The fuel spilled from the damaged wing tanks in mist form and moved to the rear of the airplane (fig. 5(a)), which was traveling about 100 miles per hour. When the nose gear collapsed upon contact with the ground, the fuselage fuel tank was pierced. Fuel poured from this tank into the engine-inlet duct. Ignition of this fuel within the engine provided a succession of flame puffs issuing from the tailpipe, one of which is shown in figure 5(b). These flame puffs moved into the wake of the airplane and continued to burn as isolated masses. Fuel spilling from the wing was ignited by these flames at the rear of the airplane (fig. 5(c)). The resulting fire moved forward through the fuel spilling from the wing and reached the slowing airplane to produce the fire shown in figure 5(d).

(a) Wing-tank fuel spillage, 0.35 second after initial impact.

(b) Flames at engine tailpipe, 0.75 second after initial impact.

(c) Wing-tank fuel mist, 1.10 seconds after initial impact.

(d) Spread of fire, 2.15 seconds after initial impact.

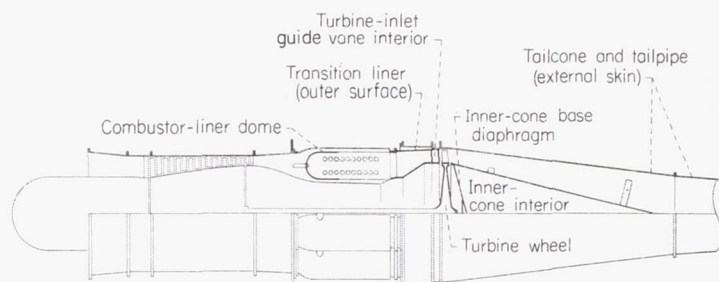
FIGURE 11.—Hot-metal ignition sources found in J35 engine.

The ignition zones were identified in test-stand engines by the method discussed in detail in appendix C. The technique employed involved the use of fuel sprays local to the engine zone suspected as an ignition source. Following engine operation at rated conditions for a time sufficient to establish temperature equilibrium, the fuel flow to the combustor was turned off and the fuel spray was turned on local to the zone under study. The fuel flow was programmed to maintain a combustible atmosphere in the zone. If ignition occurred, inerting means were installed to prevent the ignition in subsequent tests of upstream zones. By starting at the downstream end of the engine and proceeding upstream in this way, each ignition zone was identified and inerted in turn. As a final check after all the zones were inerted, fuel was injected into the main gas stream to determine whether ignition would occur. In this manner, ignition zones were found on the combustor liner, transition liner, turbine, inner cone, and tailcone and tailpipe (fig. 11).

Combustor liner: The ignition zone found on the combustor liner was the dome, which lies close to the primary

combustion zone. The metal adjacent to the dome is heated by the combustor flame and attains unsafe temperatures in spite of the cooling provided by the adjacent air. Also, in this region the engine air is caused to recirculate by design to provide a zone of low transitional speed and promote good combustion. Both the hot metal of the combustor liner adjacent to the dome and the residual flames previously discussed make this zone particularly hazardous. The size of this zone is difficult to define, since it depends on the air temperature at the compressor outlet, the combustor design, and the ignition characteristics of the combustibles sucked into the engine.

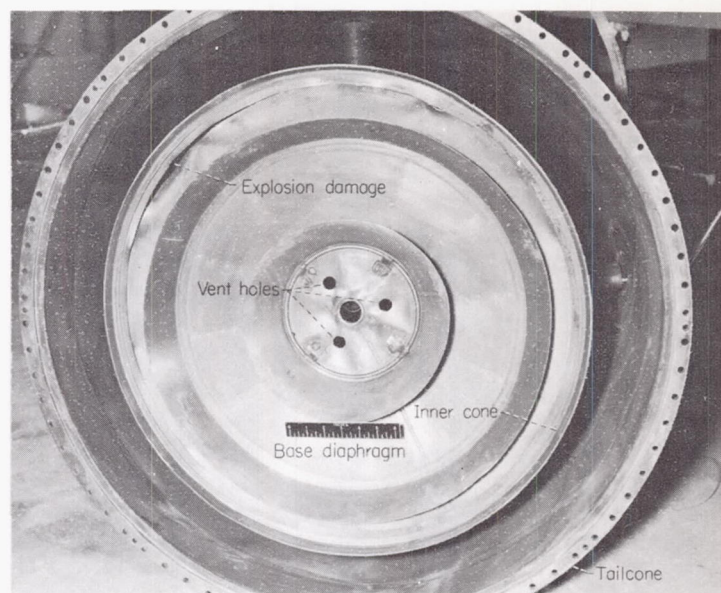
FIGURE 12.—J35 Inner-cone base diaphragm.

Inner cone: Combustible atmospheres delivered to the turbine wheel from the compressor can enter the interior of the inner cone through vent holes. In some engines these vent holes are located at the base of the tailcone as shown

in figure 12. The plane of the inner-cone base is parallel to the turbine wheel. Combustibles entering the cone could ignite on the hot walls of its quiescent interior. The slight damage to the base diaphragm, indicated in the figure, followed ignition in the interior. The resulting flame might ignite the combustible atmosphere streaming through the engine to produce the dangerous flames at the engine inlet and tailpipe shown in figure 13.

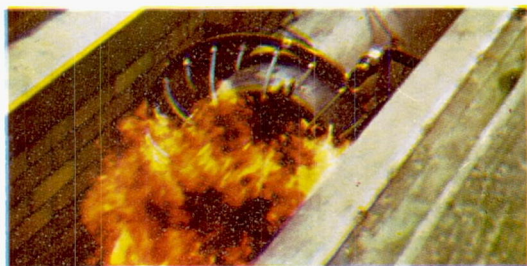
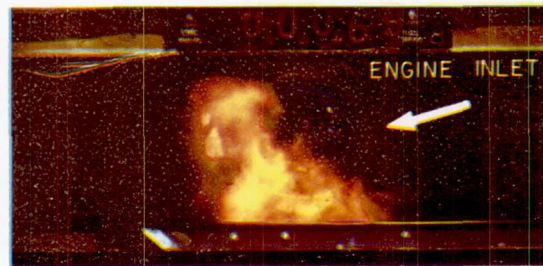
FIGURE 13.—Flames issuing from engine following explosive ignition of fuel within engine.

(a) Tailpipe

(b) Inlet.

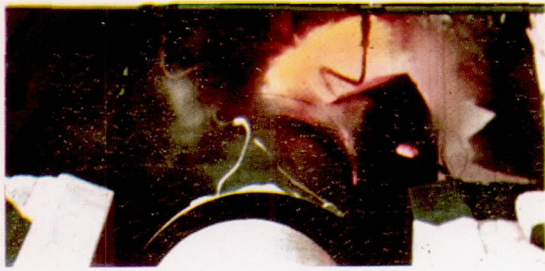
FIGURE 14.—Fuel ignition on tailcone surface.

Tailcone and tailpipe: The ignition zones discussed previously were all that were found within these engines. Experiments showed that fires could also be obtained when fuels or lubricants contacted the outside surface of the tailcone and tailpipe. The fire produced by jet fuel on an engine tailpipe is shown in figure 14. For engines having a pressure ratio of 5 or less, the unsafe exterior surfaces were confined to the tailcone and tailpipe.

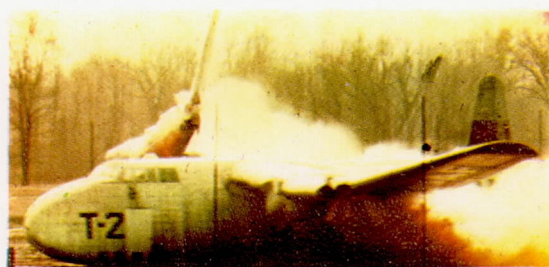
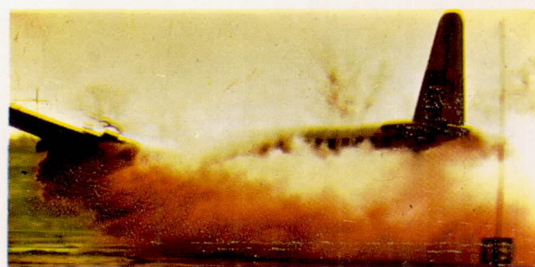
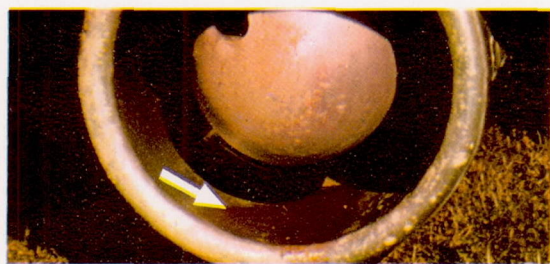
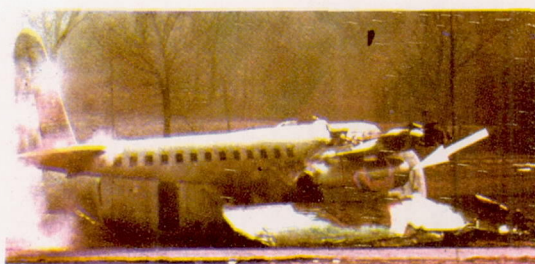
FIGURE 22.—Crash of C-82 with jet engines equipped with inerting system.

(a) Fuel mist discharging from torn wing, 0.9 second after initial impact.

(b) Entry of fuel mist into left engine, 3.0 seconds after initial impact.

(c) Pool of fuel left in inlet cowl indicating fuel entry into engine.

(d) Fuel spillage on nacelle.

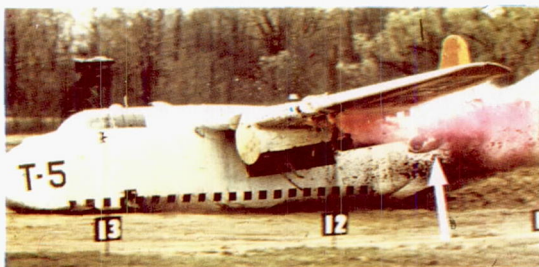
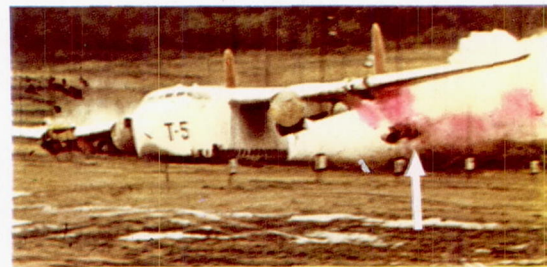
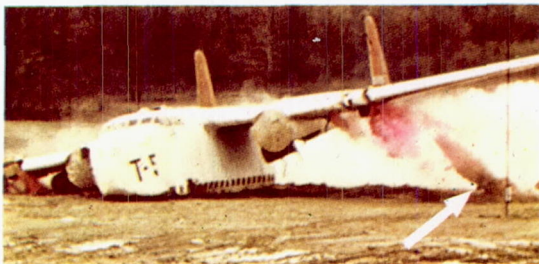
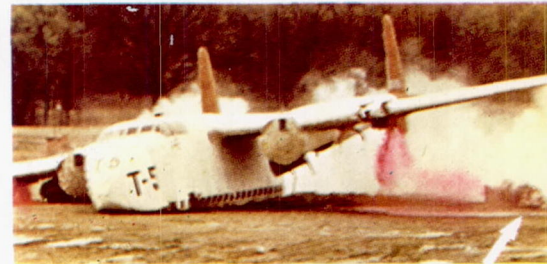
FIGURE 24.—Separation of J47 engine from C-82 wing in crash.

wake of the damaged wing (figs. 24(b) and (c)) and came to rest in the fuel-wetted slide path of the airplane (fig. 24(d)). The plume of condensed water vapor at the tailpipe (fig. 24(b)) shows that the water inerting system was actuated. No fire occurred.

(a) 1.3 Seconds after initial impact.

(b) 1.8 Seconds after initial impact.

(c) 3.1 Seconds after initial impact.

(d) 4.4 Seconds after initial impact.

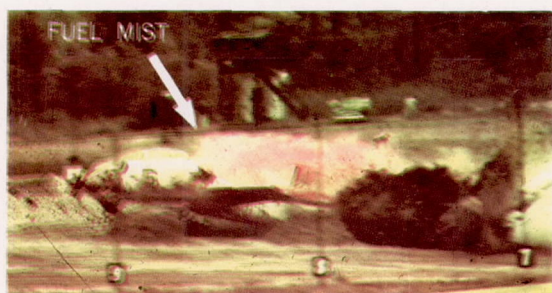
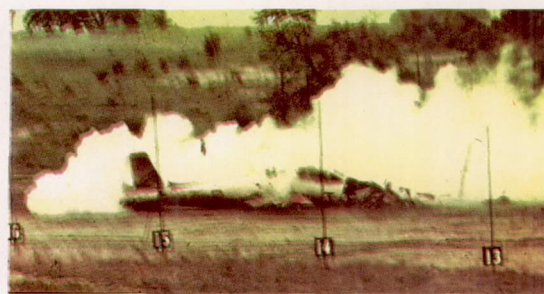
FIGURE 25.—Crash of F-84 with J35 inerting system installed.

The sequence of events following crash was the same for the F-84 as for the cargo airplanes. Poles at the crash barrier ripped open the wing fuel tanks and produced the fuel mist shown in figure 25(a). Collapse of the nose gear allowed fuel from the torn forward fuselage tank to enter the engine inlet. Vapor issuing from the tailpipe (fig. 25(b)) was provided in part by the fuel that passed through the engine from the damaged fuel tank adjacent to the engine inlet. Evaporation of water from the fire protection system contributed a large part of the vapors formed (fig. 25(b)). Inspection of the engine after crash showed the telltale dye stains left by the red-dyed fuel flowing through the compressor (fig. 26). No fire occurred.

(a) Fuel mist, 1.1 seconds after initial impact.

(b) Water and fuel vapors issuing from tailpipe, 3.6 seconds after initial impact.

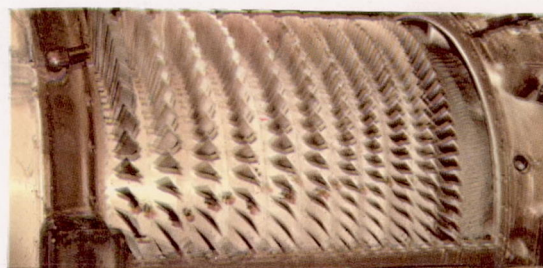
FIGURE 26.—Fuel-dye stains on J35-engine compressor following F-84 crash.

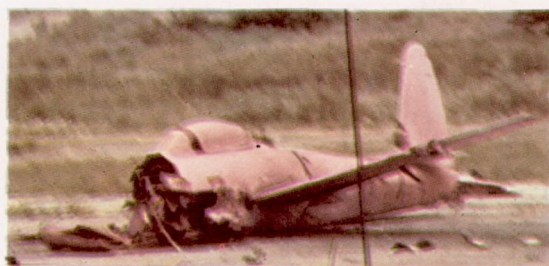
A second crash of an F-84 airplane equipped with the fire protection system was conducted, again with no fire occurring. When the airplane came to rest beyond the crash barrier, complete wetting of the airplane by the red-dyed fuel was observed (fig. 27).

FIGURE 27.—Extensive fuel wetting of F-84 following crash with inerting system.
